DEPARTMENT OF TRANSPORTATION

Quality Assurance and Source Inspection

Contract #: 04-0120F4Cty: SF/ALA Rte: 80 PM: 13.2/13.9File #: 69.28**WELDING INSPECTION REPORT****Resident Engineer:**Siegenthaler, Peter**Address:** 333 Burma Road**City:** Oakland, CA 94607**Report No:** WIR-022075**Date Inspected:** 29-Dec-2010**Project Name:** SAS Superstructure**OSM Arrival Time:** 700**Prime Contractor:** American Bridge/Fluor Enterprises, a JV**OSM Departure Time:** 1900**Contractor:** Zhenhua Port Machinery Company, Ltd (ZPMC), Changxing Island **Location:** Shanghai, China**CWI Name:** Qiu Wen**CWI Present:** Yes No**Inspected CWI report:** Yes No N/A**Rod Oven in Use:** Yes No N/A**Electrode to specification:** Yes No N/A**Weld Procedures Followed:** Yes No N/A**Qualified Welders:** Yes No N/A**Verified Joint Fit-up:** Yes No N/A**Approved Drawings:** Yes No N/A**Approved WPS:** Yes No N/A**Delayed / Cancelled:** Yes No N/A**Bridge No:** 34-0006**Component:** OBG**Summary of Items Observed:**

BAY 14, OBG (NWIT # 7977)

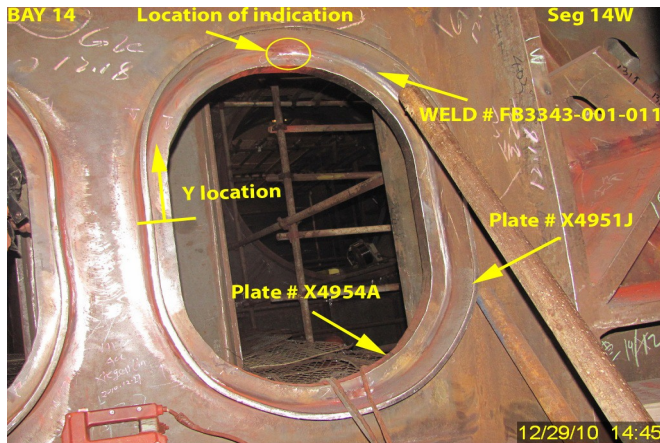
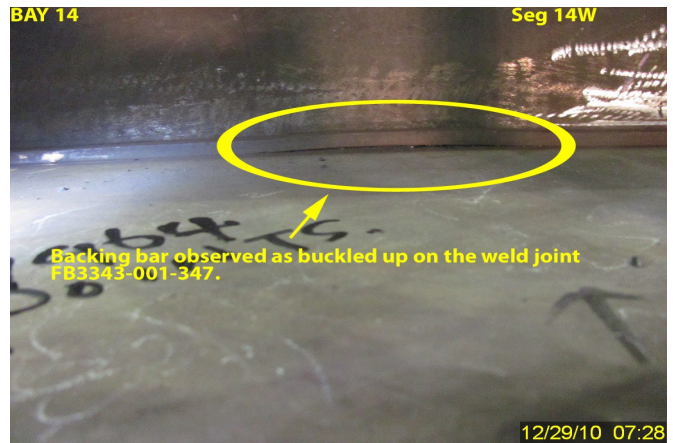
During random in process inspection this QA inspector observed that the steel backing bar of Complete Joint penetration (CJP) weld joint was buckled up. The weld joint is identified as FB3343-001-347. This issue has been discussed with ZPMC CWI Mr. Qiu Wen and CT lead QA. Mr. Qiu Wen informed this QA that this issue would be corrected in a manner compliant with the contract documents. Attached photograph provide additional detail.

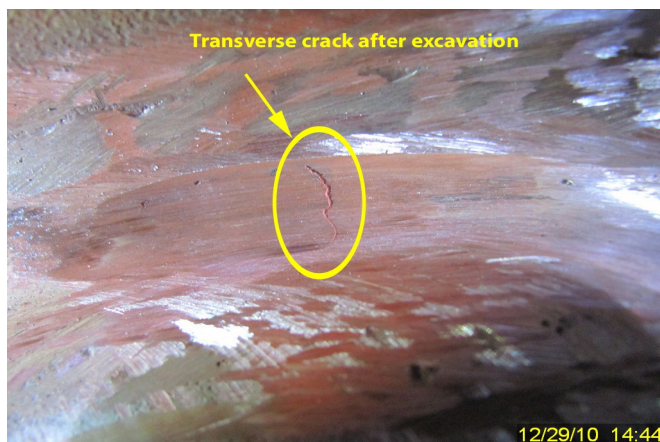
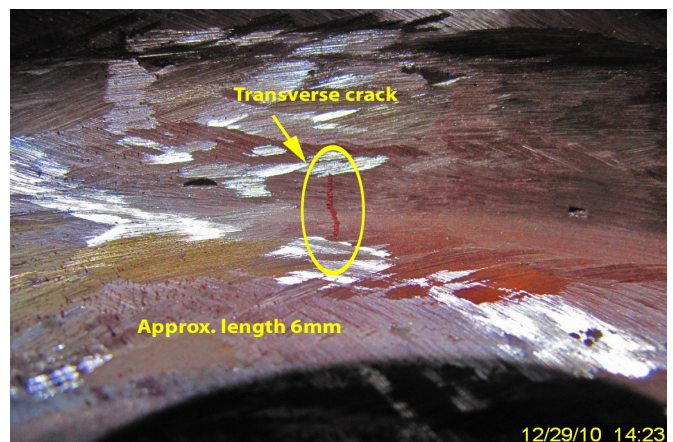
FB3343-001-011 (MT transverse crack found during inspection, IR generated)

- One (1) transverse crack found on the fillet weld measuring approximately 6mm in length.
- Y location of the indication is measured to be 485mm approx. (as shown in picture).
- The indication is clearly marked on the weld joint.
- The weld is identified as: FB3343-001-011.
- The Weld is a fillet weld joining the plate X4951J to the plate X4954A of Floor Beam (FB) 3343 at Panel Point (PP) 128.3.
- The weld is identified as Fracture Critical Weld (FCW).
- The member is located in bay 14.

The Notice of Witness Inspection Number (NWIT) is 07972. The indication is located outside the area that has been previously tested and accepted by ZPMC Quality Control (QC) personnel. ZPMC QC personnel performed 25% MT on these components. The attached photographs provide additional detail.
